**Joint Network Secretariat
Urgent Procedure Task Force
Broken wheels**

**Agreement of the TF on
short term mitigation measures**

Task Force Broken wheels – Proposal Short Term measures Summary

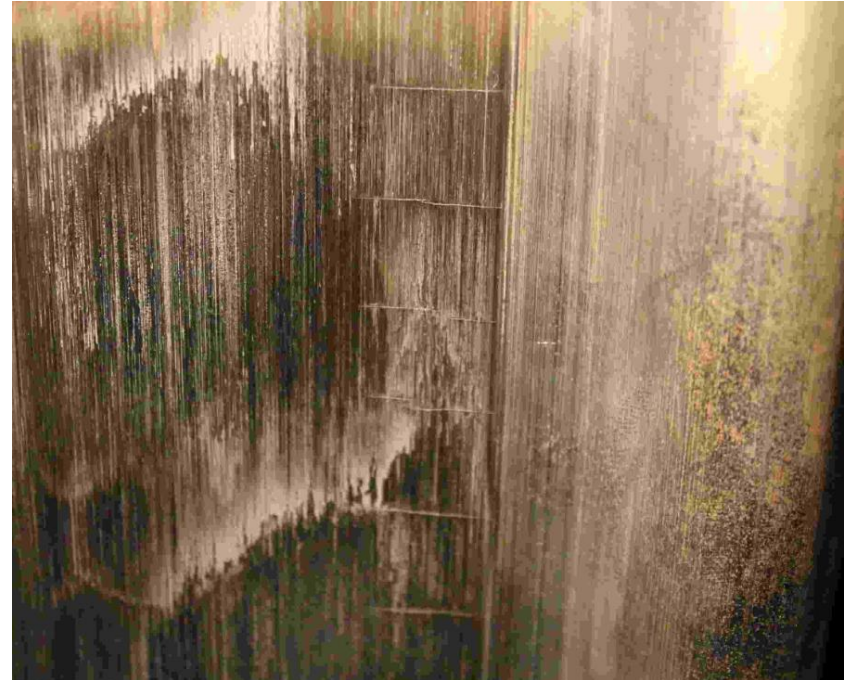
Description: The tread exhibits cracks at an angle of approximately 90° to the circumference of the wheel and have a typical length of 30mm or more. Transverse cracks generally develop at the surface in either straight or slightly crooked lines and can penetrate radially (usually of thermal origin in these cases) or branch out in a circumferential direction (usually of mechanical origin in this case). They occur individually and can be distributed at several points around the circumference. [EN 15313, §C.2.6]

Transverse crack revealed by magnetic particle testing [EN 15313, §C.2.6]

* single cracks on the wheel tread ("isolated transverse cracking" cf. EN 15313 §C.2.6 and 6.2.3.4) – Criteria: see slide 8

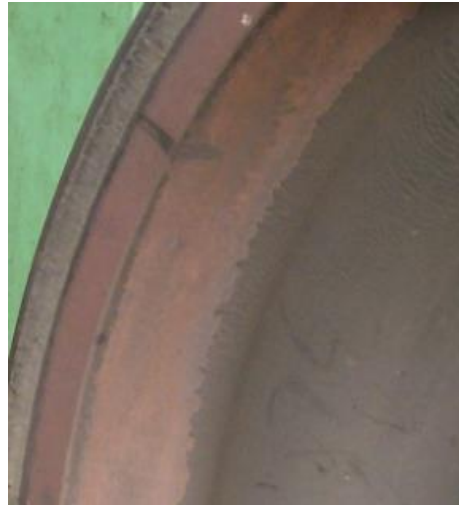
Old and fresh burnt paint

** any indication of thermal overload of the wheel (burnt paint, excessive wheel deformation, cf. EN 15313 §C.3.2.2 and 6.2.4.3) – Criteria: see slides 9 and 10

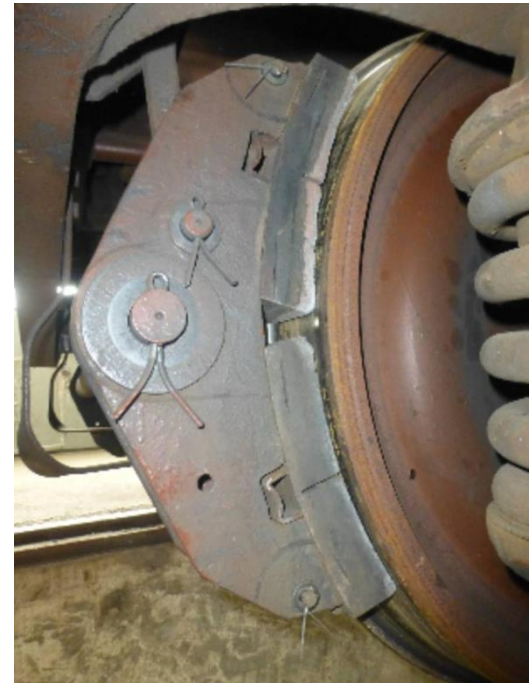
Melted brake block
