Proposed amendment to Appendix 9 to the GCU

Title:	New drawing for the correct assembly of tare springs and load springs in the suspension systems of Y 25 bogies or derived systems
Proposed amendment made by RUs/keepers/others:	MERCITALIA RAIL/AFWP Appendix 9 subgroup
Proposed amendment to:	<input checked="" type="checkbox"/> Appendix 9 <input type="checkbox"/> Appendix 11
Proposer:	Francesco Garrisi, Mercitalia Rail
Location, date:	Florence, 07/01/2021
Concise description:	New drawing, code 2.5

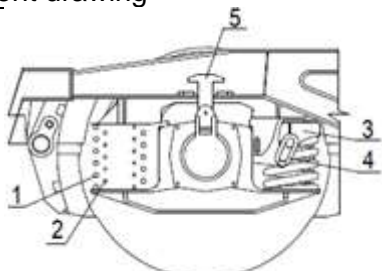
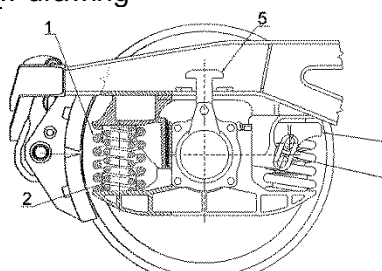
Current drawing	New drawing

The suspension system of Y 25 bogies is implemented by means of two helical springs, one of which - the tare spring - is external, with the other spring - the load spring - contained inside it. Both springs must be assembled with the coils wound in the opposite direction to each other.

GCU Appendix 9, Annex 1 does not contain a damage code for incorrect assembly of springs and for management of non-compliance in respect of the suspension system of Y 25 bogies. There is a need to more clearly illustrate that the two springs must be assembled with the coils wound in the opposite direction to each other.

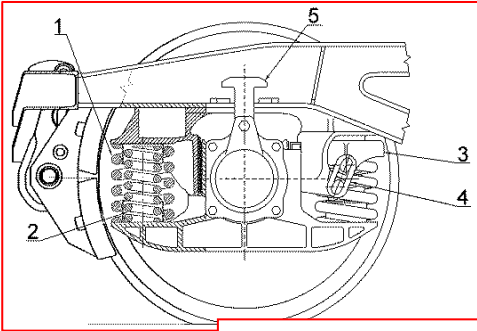
Component	Code no.	Irregularities/Criteria/Notes	Action to be taken	Irregularity class
Suspension system of Y 25 bogies or derived systems	2.5

<p>1 Tare spring* 2 Load spring* 3 Spring cap 4 Damper ring 5 Lifting T</p> <p>*Coils wound in opposite directions</p>		
	2.5.1	Main/tare spring cracked or broken	Detach wagon	5
	2.5.2	Auxiliary/load spring displaced or broken		
	2.5.2.1	- on empty wagon	K	4 3
	2.5.2.2	- on loaded wagon • axle box no longer horizontal	Detach wagon	5

The external tare springs work when the wagon is empty.
The internal load springs also work when the wagon is loaded.
